SmartPlaz
Think Smart

Traditional Boxend Protection

One Step Closer

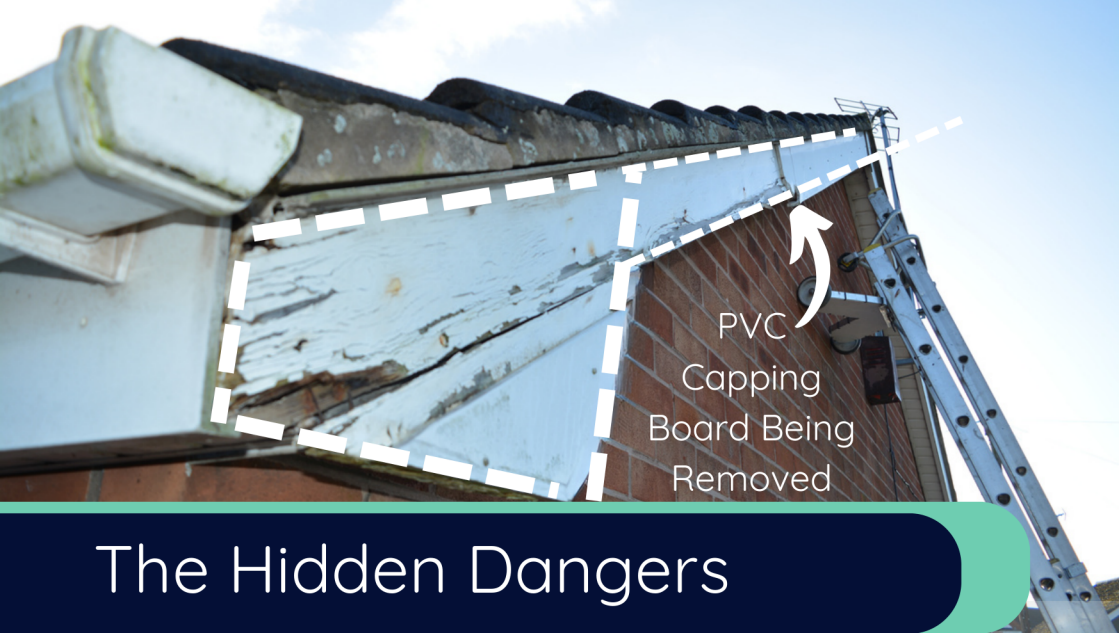
One Piece Box end Problem

We've found water infiltrating behind these one-piece boxends, evident in the rotting fascia and, more critically, the structural roof rafter.

Water infiltration is a serious issue that can cause extensive damage to a building's structure over time. In this case, the one-piece boxends have allowed water to seep in, leading to rotting fascia and a compromised structural roof rafter. It's important to address this issue as soon as possible to prevent further damage and potential safety hazards. A professional inspection should be conducted to determine the extent of the damage and the best course of action for repairs. Regular maintenance and inspections can also help prevent water infiltration issues from occurring in the first place.

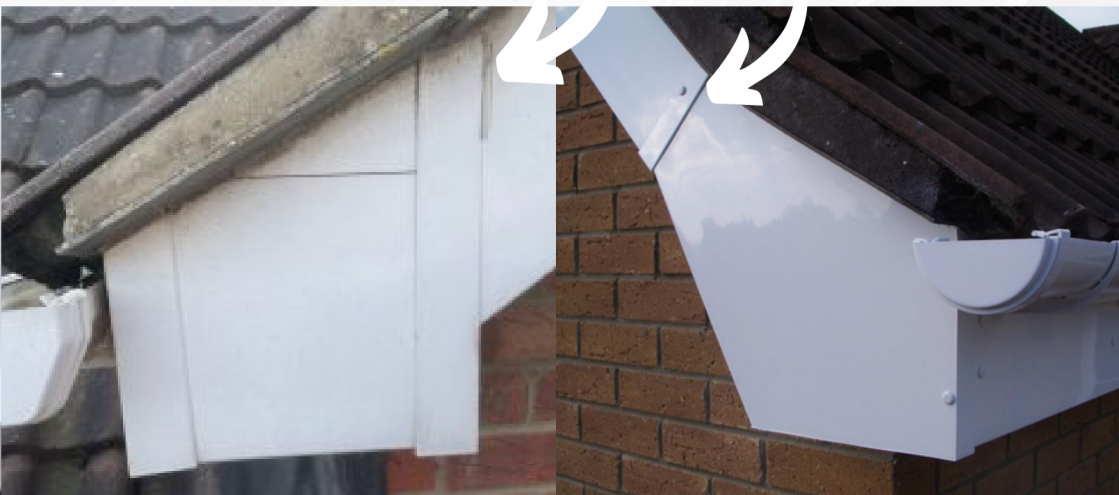
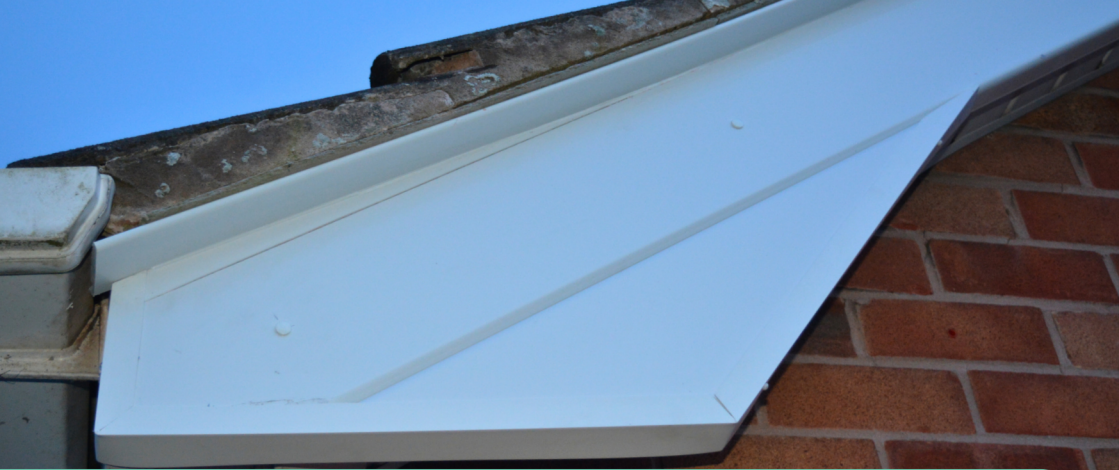
Why This Is Happening

These one-piece boxends feature a joining strip covering the expansion joint. Plastic expands, enlarging the gap, increasing the likelihood of moisture finding its way behind the fascia. This can lead to the onset of rot in the wooden rafters.

Smartplaz have been installing this style of boxend for over 25 years, because UPVC expands and contracts it creates gaps allowing water to penetrate. Any vertical expansion on a boxed end can lead to water seeping behind the fascia, initiating the rotting process of the rafter, as we are now discovering!

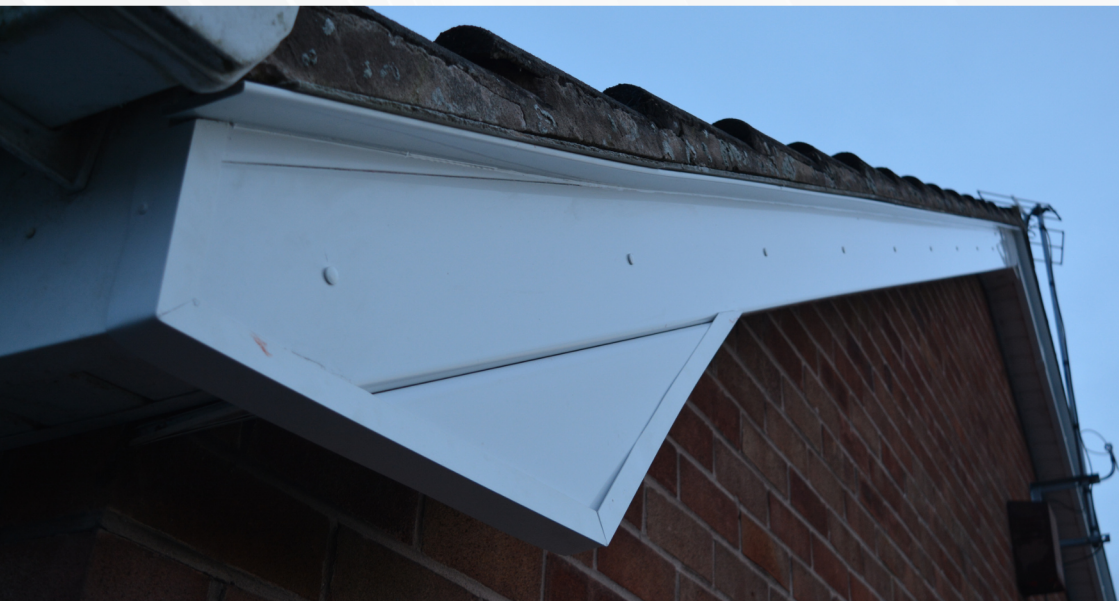
Traditional Box End Solution

A traditional seamless upvc Bargeboard without joints on the box end provides complete protection for your roof rafter.

Make sure that your PVC box ends are installed using the traditional looking method.
